the NEWS

The Salt Air Nemesis And Solutions

By Robert Fyler
For *The News*

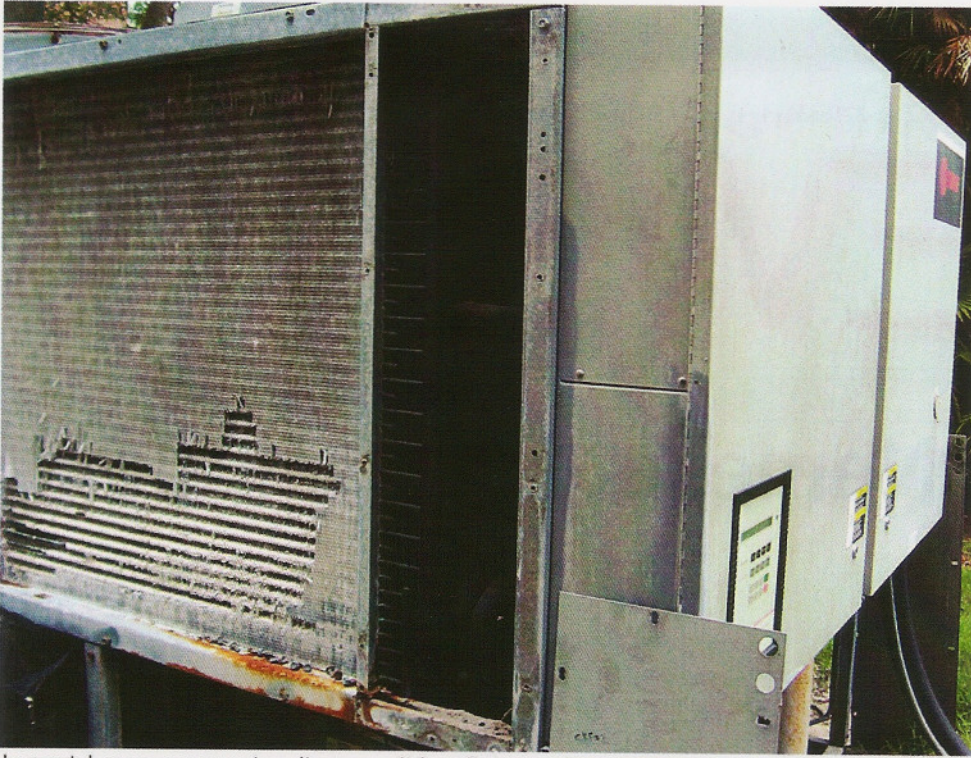
In coastal areas, exposure to salt can result in coil damage that shortens the life of the equipment.

Working in the HVAC industry in Florida, I have observed many condenser coils exposed to salt air and the damage it has caused. Bare aluminum fins can deteriorate rapidly depending on a number of factors including fin design, location of the equipment relative to the salt water, and maintenance. A typical indication of corrosive damage is visible in the disintegration of the fin, often resulting in flaking of the aluminum. In severe cases, strips of the fins will peel away from the copper tube, disrupting the mechanical bond to the tube and reducing the finned surface area and its ability to transfer heat. Some of the disintegrated fin material can be pulled into the coil, obstructing airflow and further reducing overall heat transfer.
