Spatter Matters

Nissan's journey towards spatter-free welding

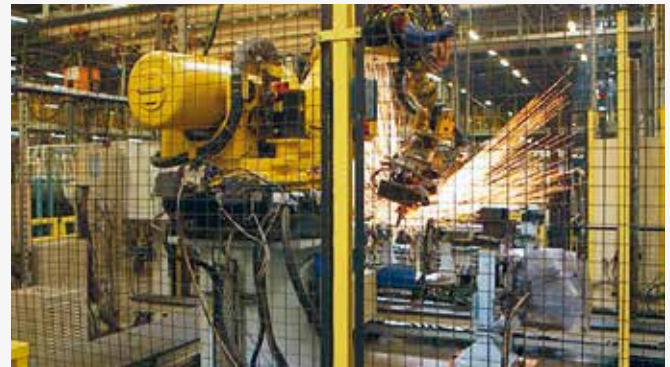
NMUK Standard Parameter

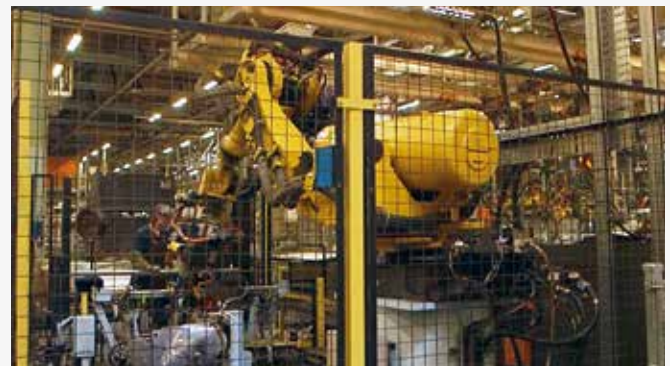
NMUK Spatter Reduction Parameter

"We switched to using Luvata electrodes, but mainly focused on the actual cost benefits, not the long-term costs of the spatter," indicates the Weld Team Supervisor from NMUK. "The welding expert from Luvata was persistent in explaining we needed to consider those costs as well. With Luvata's expertise, we worked together to select the correct material weld cap and fine tuned the welding parameters to enable the reduction of weld spatter."
